ST MARY MAGDALEN CHURCH ~ FIFEHEAD MAGDALEN

WALL MONUMENTS

OUTLINE CONDITION ASSESSMENT AND CONSERVATION RECOMMENDATIONS

AUGUST 2016

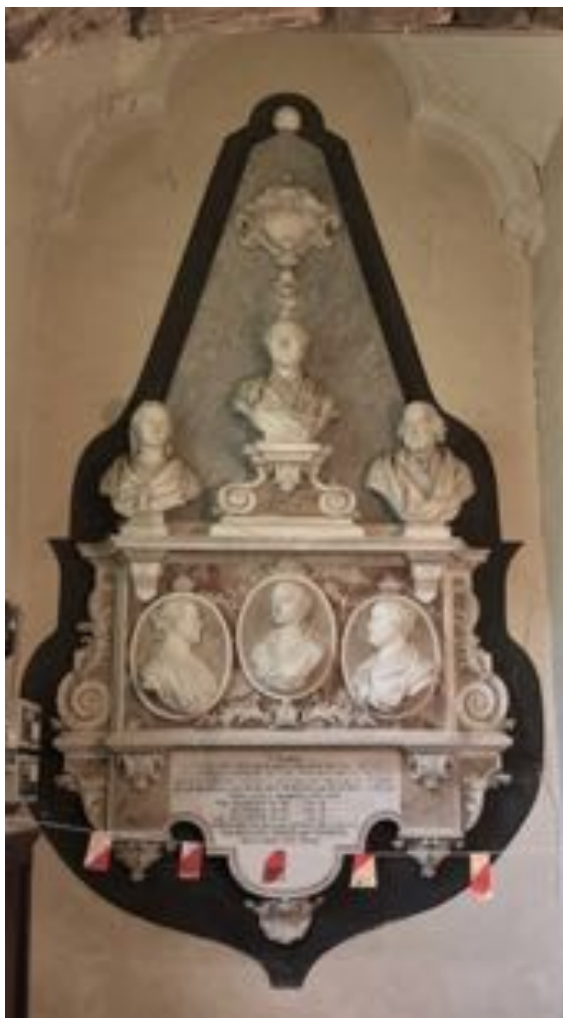
General ~ The structural condition of this monument is poor. Cracks are evident to the north elevation on both the east and west of the monument. These extend up to and across the ceiling.

Losses ~ At least one marble element is detached or lost.

Ferrous fixings ~ The upper half of the monument has moved away from the wall. This is likely to have been caused by corroding iron fixings. The lower half of the monument is more stable.

Stability ~ the corrosion of the fixings is on-going and movement is noted particularly at high level. Joints are open. Bronze dowels were noted to support some of the smaller elements. These are stable.

Cracks ~ Some of the marble elements are cracked, broken and at least one has detached.

Soiling ~ The monument is dirty and the covered with a large amount of loose dust and debris.

Polychromy ~ The inscription is in-painted and legible, however some of paint is lost giving it an uneven appearance. A painted black border frames the monument on the plastered wall. Although this has been repainted it is likely to be over an original similar border. It would be interesting to establish if this exists and the extent of the border.

- Record location of all elements to ensure re-assembly in the original position.
- Collect, label and bag detached fragments for reinstatement during conservation works. Record the location where all fragments are found

- Carefully dismantle upper sections. Commence with the busts. Allow for any holding conservation and protections required during the lifting and moving. Set to one side and protect. It is hoped and anticipated that the lower sections may remain in situ. All efforts must be made to retain the painted plaster surrounding the monument, in particular the painted black border. This may not be possible in all instances.

- Assess lower sections
- Examine the structure behind. (Determine necessity for and extent of further interventions.)
- Fill cracks to north elevation. Monitor further opening for signs of movement and structural instability.

- Remove remains of pointing and bedding mortars.
- Remove corroding ferrous cramps/fixings.
- Re-fix dismantled elements on wall incorporating a DPM using stainless steel 316 armatures.

- Repair elements using stainless steel and epoxy resin (Akemi or Marmolit).
- Clean all elements in-situ and ex-situ using selected methods based on the results of the trials.

- Re-fix busts bedding on Plaster of Paris and incorporating stainless steel pins / cramps where necessary.
- Re-point and fill all joints with Plaster of Paris.

- Consolidate friable polychromy and applied decoration (inscription and surround)

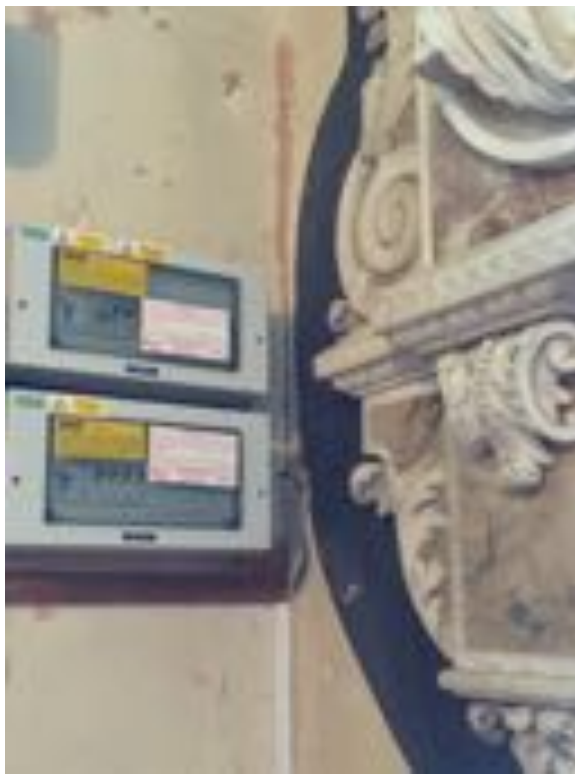
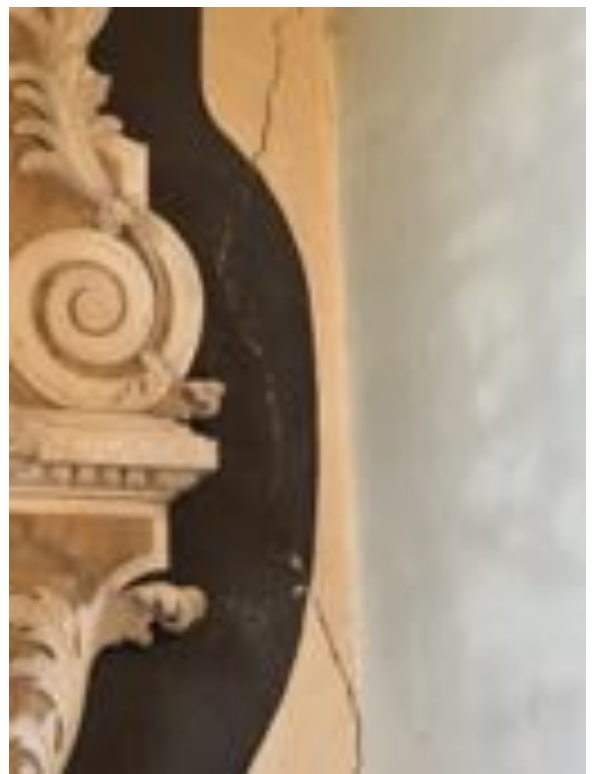
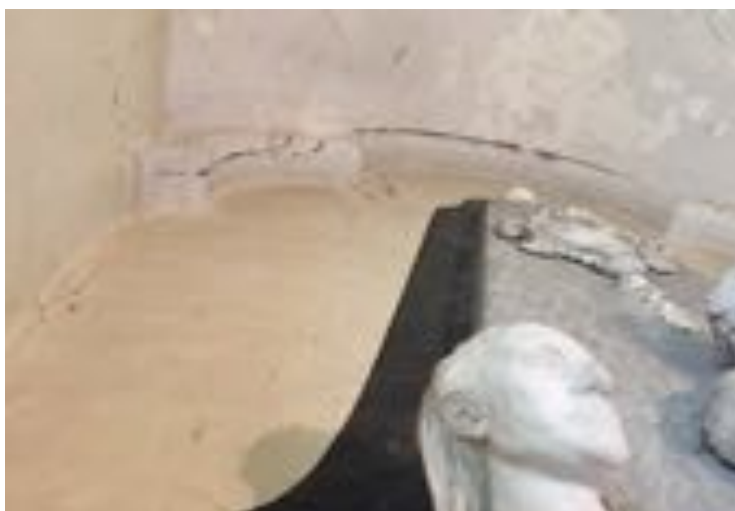
Figure 4, 5 & 6 ~ Details of cracks to the east and west of the monument, as well as extending across the ceiling.

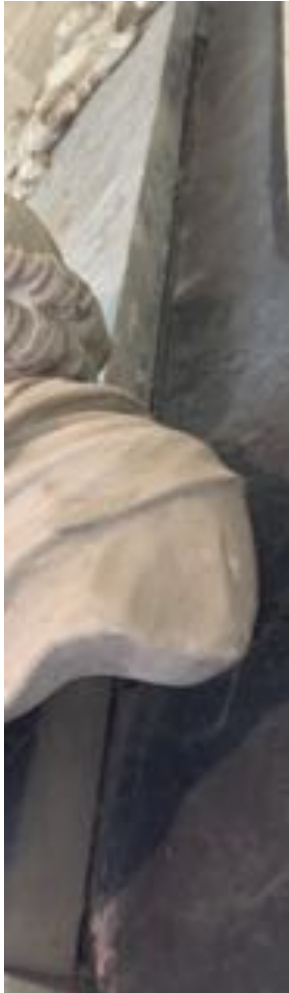
Figure 7 ~ Obelisk back plate detaching along full height on east side.

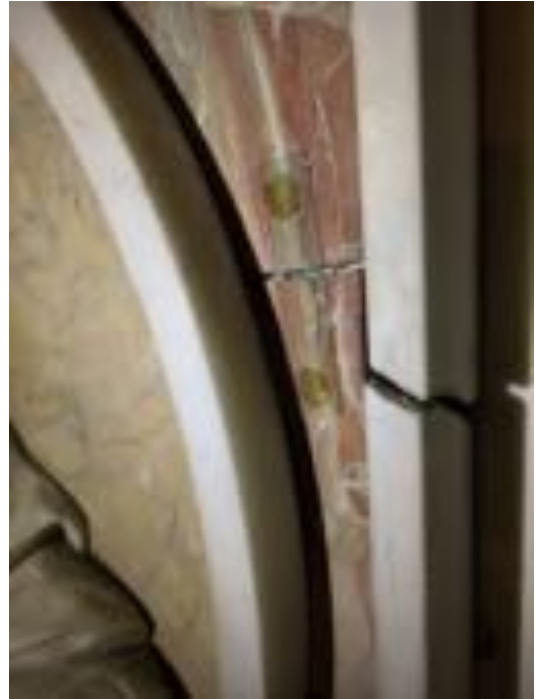
Figure 8 ~ An historic tell-tale across a crack to the upper east of the monument is in tact and appears to still be adhered. This implies that the movement has ceased. However the date of the tell tale is unknown.

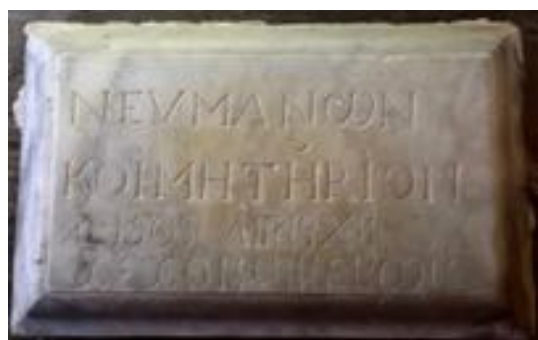
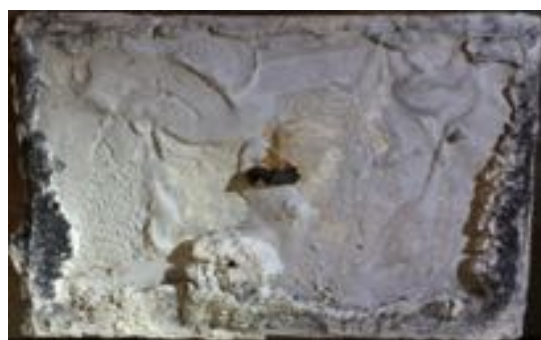
General ~ one element has detached from the base element of the monument; stability of remaining elements is acceptable.

Figure 10 & 11 ~ Front and rear view of white marble inscription detached from lower element.

Losses ~ No losses were noted. However white marble element applied to base had detached.

Ferrous fixings ~ Corroded fixing on detached element.

- Re-fix detached element using Stainless steel 316 or carbon fibre dowel.
- Clean all elements (methods to be based on results of trials)
- Consolidate friable polychromy and applied decoration
- Repoint open joints
- Inpaint losses to black surround

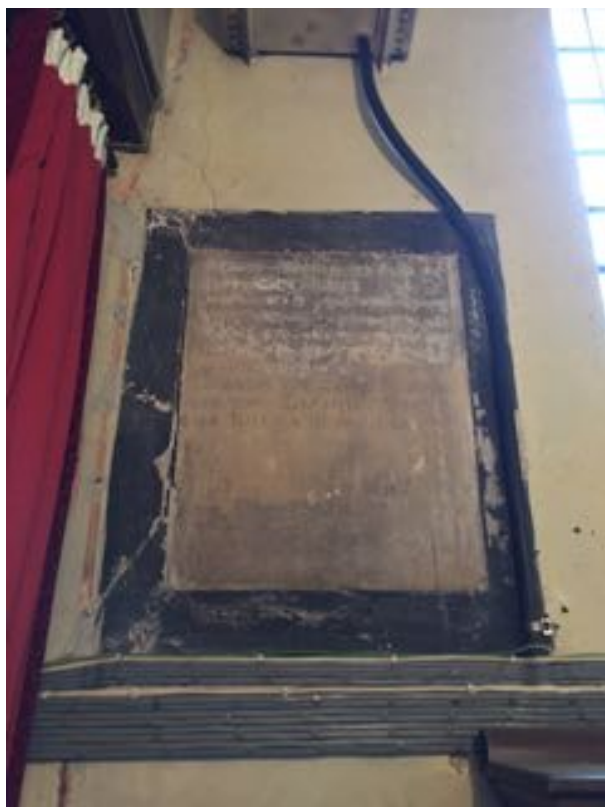
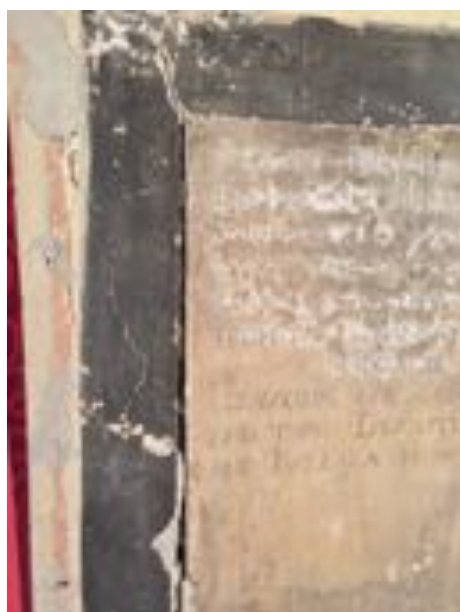
General ~ Heavily soiled with surface loss and structural cracking to the south. Water pipe runs down the north side.
Losses ~ Surface loss in areas and adjacent to cracks on frame.
Ferrous fixings ~ unknown.
Stability ~ secure, however the crack requires attention and monitoring
Soiling ~ all areas are soiled.
Inscription unclear
Surface friable particularly to upper areas

- Record all
- Assess for ferrous fixings
- Fill open joints and monitor for future movement
- Clean all and record. Assess requirement to consolidate friable areas.
- Consider legibility of inscription. If evidence of original paint, consider repainting.

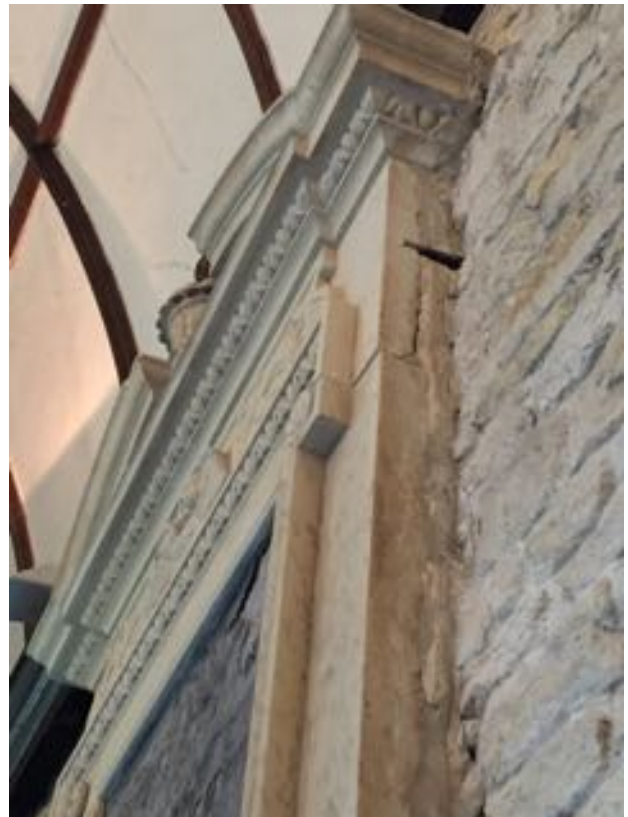
Figure 16 ~ Crack at high level along the side of the monument.

- Record all.
- Assess necessity to dismantle upper sections and record location of all elements to ensure re-assembly in the original position.
- Collect, label and bag any detached fragments for reinstatement during conservation works. Record the location where all fragments are found.

- Carry out emergency consolidation of the inscription panel to ensure no further losses.
- Carefully dismantle upper sections. Allow for any holding conservation and protections required during the lifting and moving. Set to one side and protect. It is hoped and anticipated that the lower sections may remain in situ. Assess lower sections

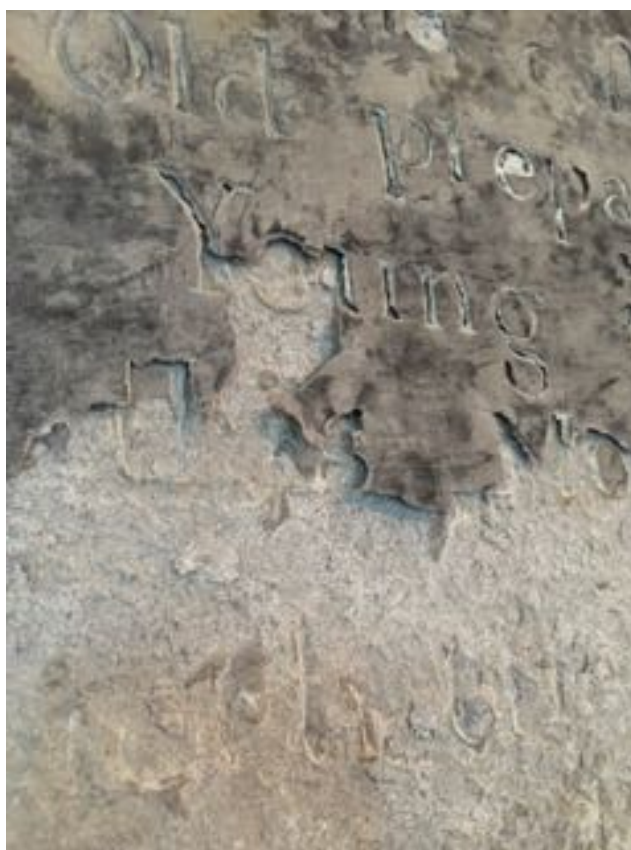
Losses ~ extensive on-going surface loss of inscription tablet

Figure 17 ~ Laminating surface of inscription panel.

- Re-point and fill all joints with Plaster of Paris.
- Consolidate friable inscription panel and apply mortar fillets to laminating areas. Grout any voids using pigmented dispersed hydrated lime.

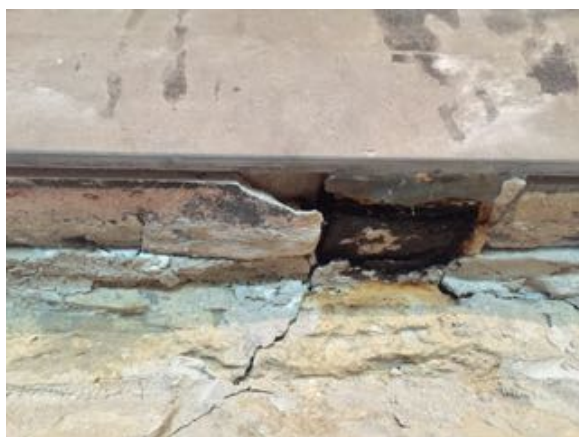
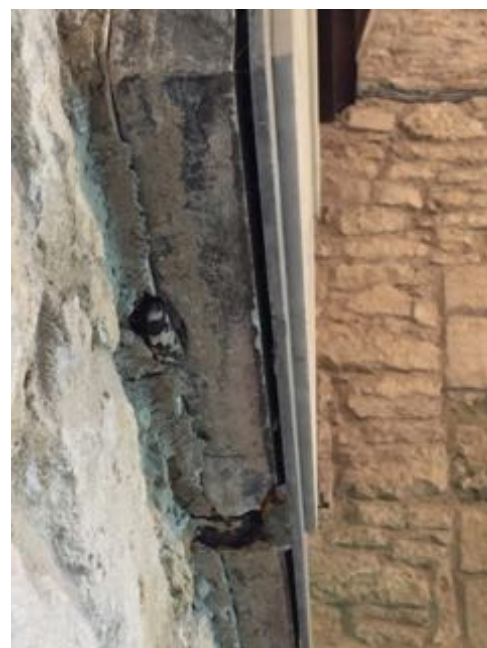
General ~ Monument detaching from wall

Ferrous fixings ~ corroded and expanding. Most notable at lower edge

Stability ~ corrosion of the fixings is on going, stability compromised and detaching from wall

Figure 19 & 20 ~ Corroding ferrous armature causing monument to detach from wall

- Record all
- Monitor fixings
- Dismantle all and refix using stainless steel armatures with a DPM against wall
- Clean all
- Consider repainting inscription to improve legibility
- Apply microcrystalline wax to marble

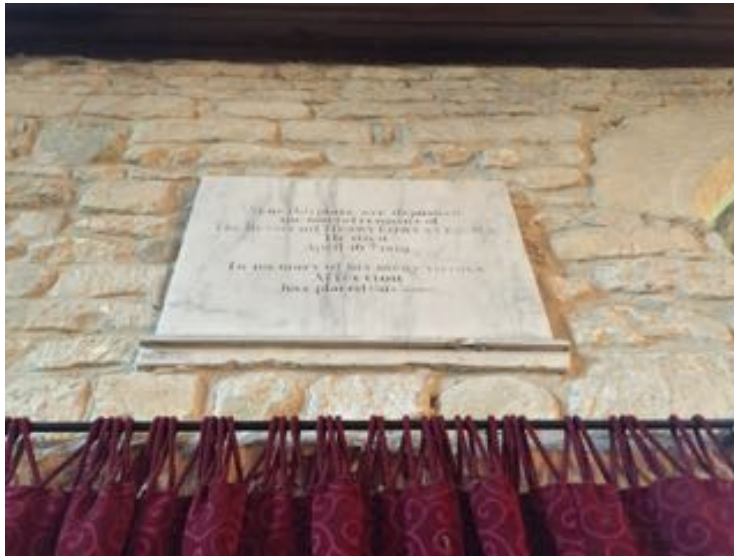
General ~ generally sound at present, however bronze fixings corroding and cracked support ledge

Losses ~ loss to front moulding of support ledge adjacent to crack

Fixings ~ bronze fixings corroded. Possible ferrous fixing on ledge.

Stability ~ relatively secure. Ledge cracked

- Record all.
- Monitor fixings
- Assess condition of support ledge and fill.

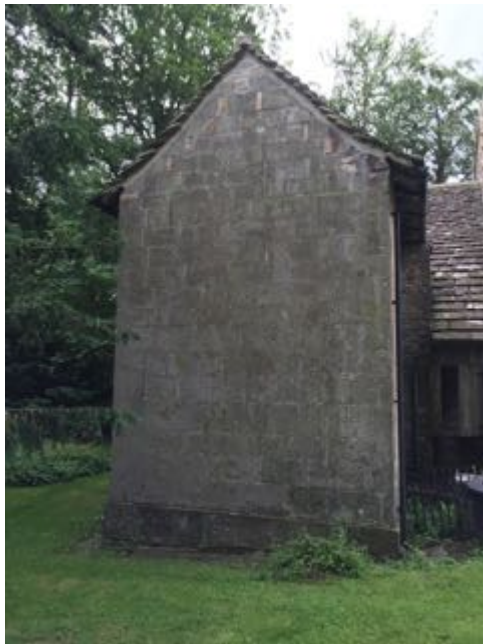
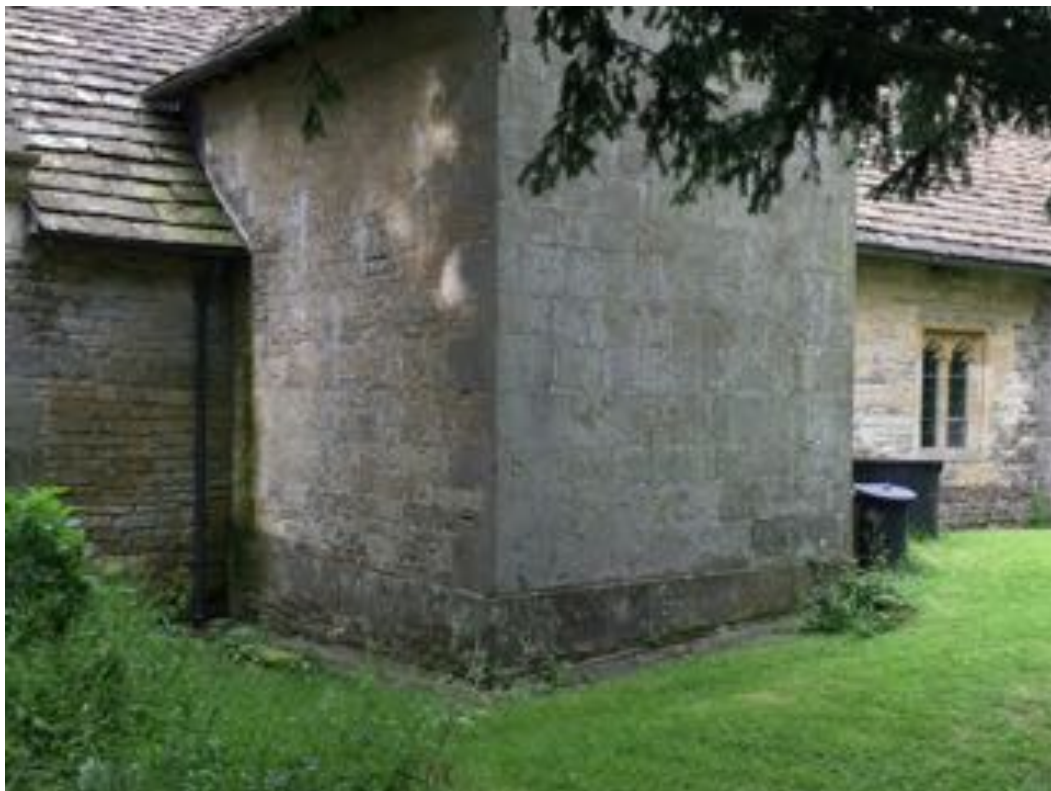
Figure 25 & 26 ~ North elevation of Newman chapel above and north east corner below. The perimeter footprint of the chapel is clear however algae on the east wall adjacent to the down pipe implies there might be an issue with the correct functioning of the rainwater goods.

It is important to regularly check and clear the rainwater goods to ensure they do not get blocked.

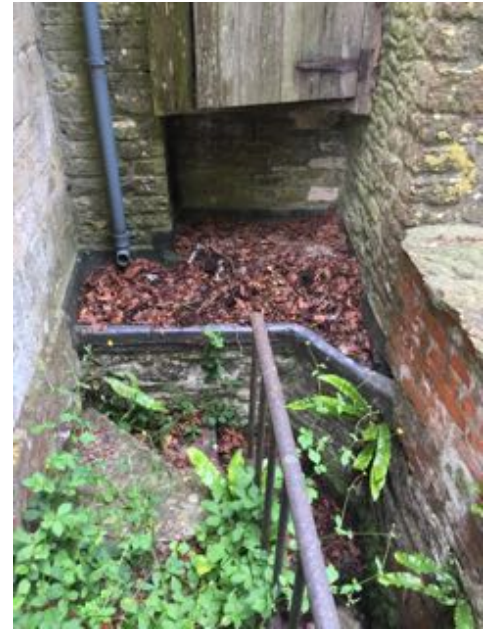
Figure 28 ~ Detail of area to west of Newman Chapel. A build up leaves at base of down pipe.
