ST MARY MAGDALEN CHURCH ~ FIFEHEAD MAGDALEN

WALL MONUMENTS

OUTLINE CONDITION ASSESSMENT AND CONSERVATION RECOMMENDATIONS

AUGUST 2016

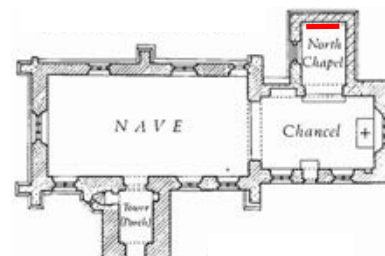
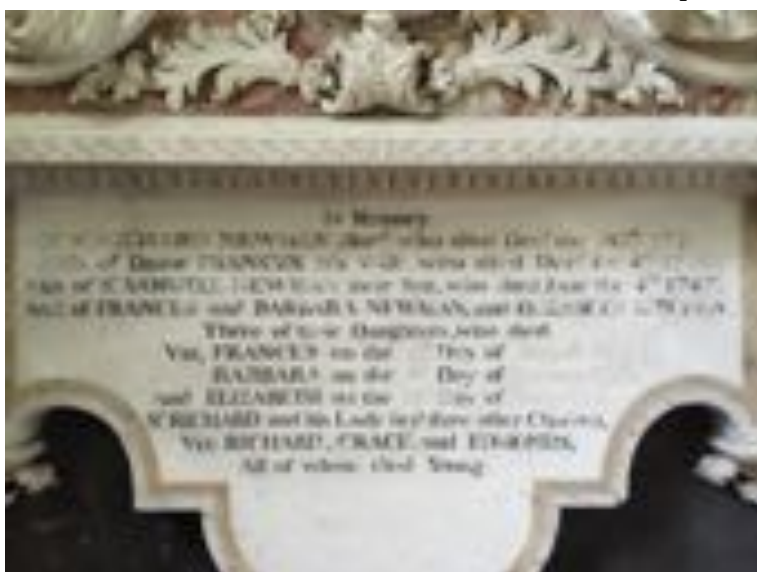
General ~ The structural condition of this monument is poor. Cracks are evident to the north elevation on both the east and west of the monument. These extend up to and across the ceiling.

Ferrous fixings ~ The upper half of the monument has moved away from the wall. This is likely to have been caused by corroding iron fixings. The lower half of the monument is more stable.

Stability ~ the corrosion of the fixings is on-going and movement is noted particularly at high level. Joints are open. Bronze dowels were noted to support some of the smaller elements. These are stable.

Cracks ~ Some of the marble elements are cracked, broken and at least one has detached.

- Record location of all elements to ensure re-assembly in the original position.
- Collect, label and bag detached fragments for reinstatement during conservation works. Record the location where all fragments are found

- Assess lower sections
- Examine the structure behind. (Determine necessity for and extent of further interventions.)
- Fill cracks to north elevation. Monitor further opening for signs of movement and structural instability.

- Remove remains of pointing and bedding mortars.
- Remove corroding ferrous cramps/fixings.
- Re-fix dismantled elements on wall incorporating a DPM using stainless steel 316 armatures.

- Repair elements using stainless steel and epoxy resin (Akemi or Marmolit).
- Clean all elements in-situ and ex-situ using selected methods based on the results of the trials.

- Re-fix busts bedding on Plaster of Paris and incorporating stainless steel pins / cramps where necessary.
- Re-point and fill all joints with Plaster of Paris.

- Consolidate friable polychromy and applied decoration (inscription and surround)

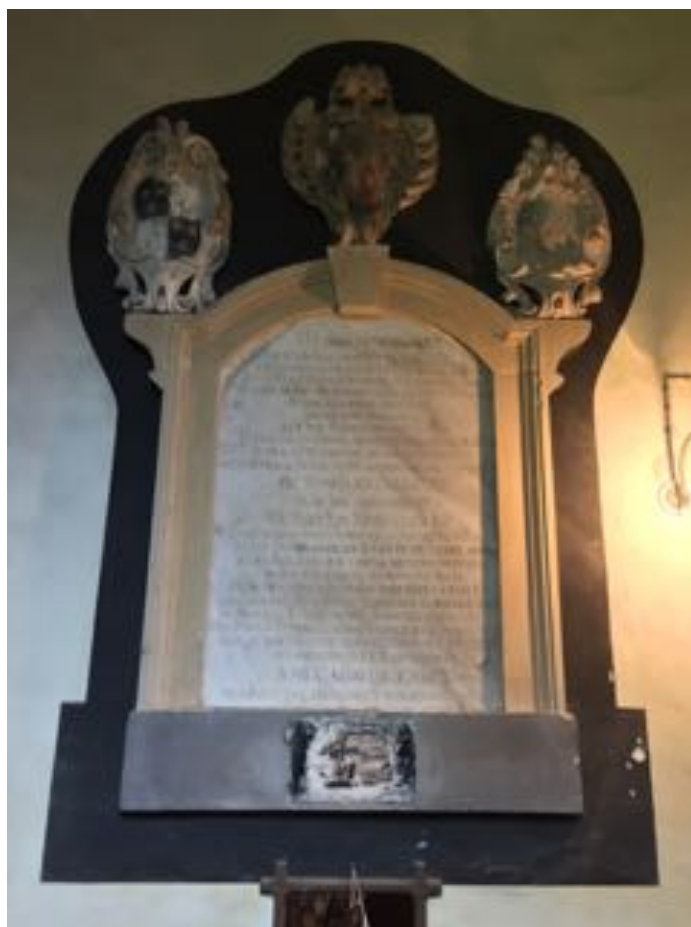
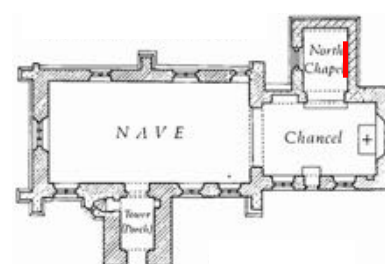
Losses ~ No losses were noted. However white marble element applied to base had detached.

Ferrous fixings ~ Corroded fixing on detached element.

Stability ~ Relatively stable. Corrosion of the fixings will be on going, however their condition does not warrant dismantling at this stage.

- Re-fix detached element using Stainless steel 316 or carbon fibre dowel.
- Clean all elements (methods to be based on results of trials)
- Consolidate friable polychromy and applied decoration
- Repoint open joints
- Inpaint losses to black surround

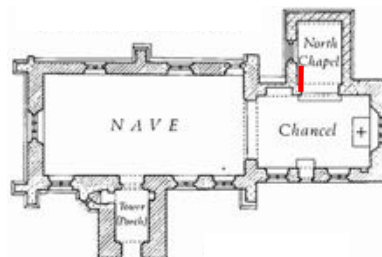
General ~ Heavily soiled with surface loss and structural cracking to the south. Water pipe runs down the north side.
Losses ~ Surface loss in areas and adjacent to cracks on frame.
Ferrous fixings ~ unknown.
Stability ~ secure, however the crack requires attention and monitoring
Soiling ~ all areas are soiled.
Inscription unclear
Surface friable particularly to upper areas

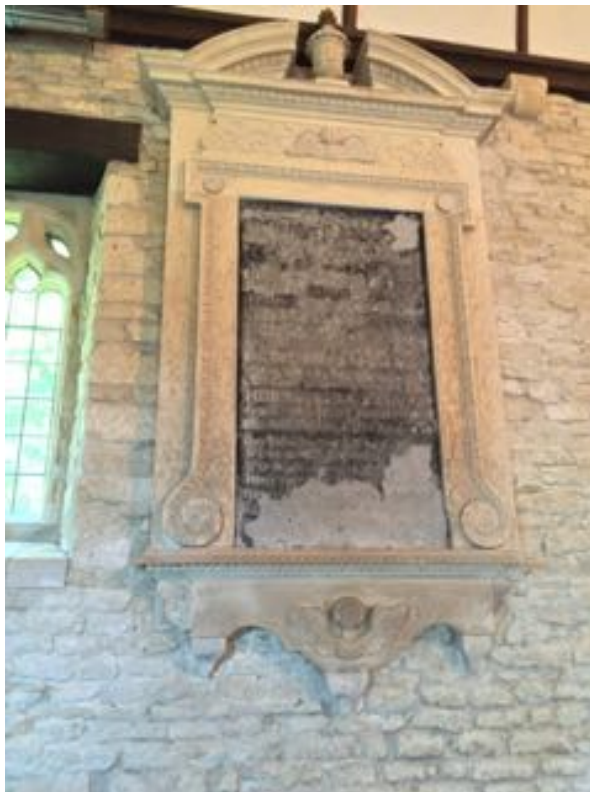
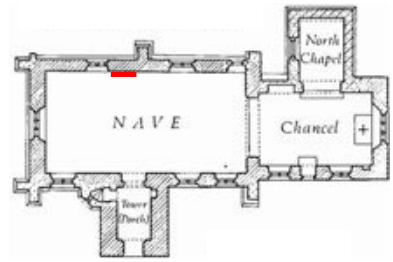
General ~ evidence of corroding fixings and heave/movement away from wall.

Ferrous fixings ~ corroded

Stability ~ the corrosion of the fixings is on-going and movement is noted particularly at high level

Soiling ~ all areas are soiled. Staining from bat droppings is evident across all surfaces.

- Record all.
- Assess necessity to dismantle upper sections and record location of all elements to ensure re-assembly in the original position.
- Collect, label and bag any detached fragments for reinstatement during conservation works. Record the location where all fragments are found.

- Remove remains of pointing and bedding mortars.
- Clean all using selected methods based on the results of the trials.
- Remove corroding ferrous cramps/fixings.

- Re-fix dismantled elements incorporating a DPM between wall and marble. Use stainless steel 316 armatures.
- Clean all elements in-situ and ex-situ.
- Bed on Plaster of Paris and incorporating stainless steel pins / cramps where necessary.

- Re-point and fill all joints with Plaster of Paris.
- Consolidate friable inscription panel and apply mortar fillets to laminating areas. Grout any voids using pigmented dispersed hydrated lime.

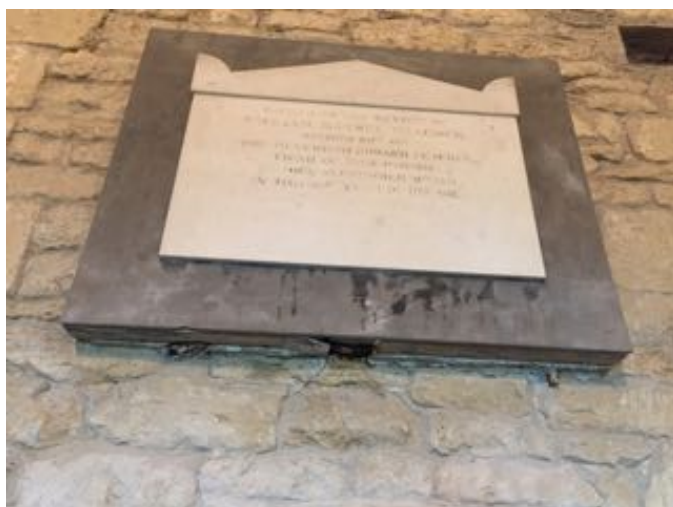
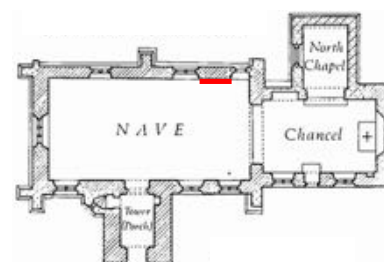
Ferrous fixings ~ corroded and expanding. Most notable at lower edge

Stability ~ corrosion of the fixings is on going, stability compromised and detaching from wall

- Record all
- Monitor fixings
- Dismantle all and refix using stainless steel armatures with a DPM against wall
- Clean all
- Consider repainting inscription to improve legibility
- Apply microcrystalline wax to marble

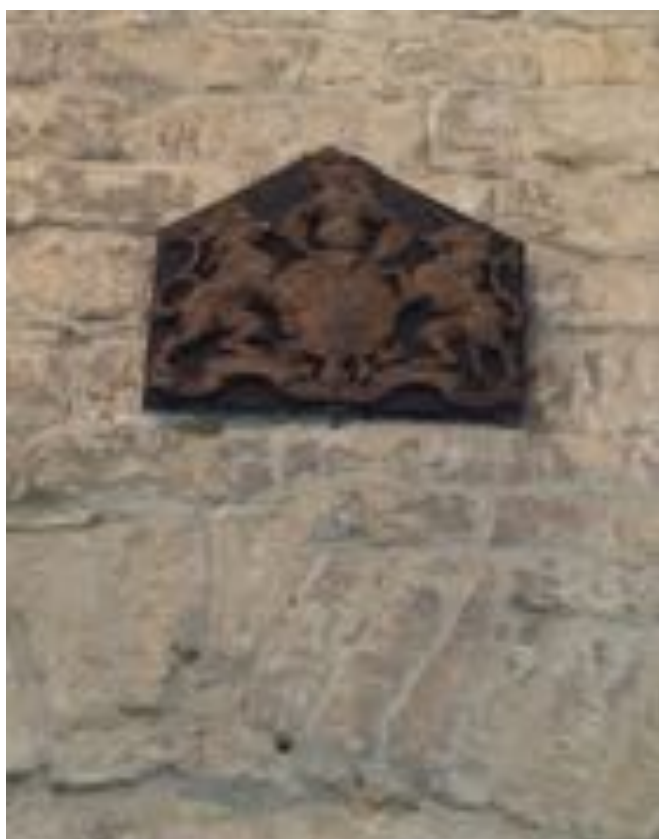
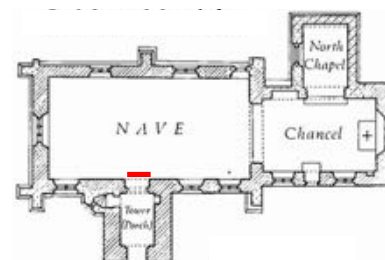
Viewed from ground level. Close inspection recommended.

- Record all
- No urgent conservation required at this stage
- Would benefit from cleaning and further inspection. Possibility to remove over paint.

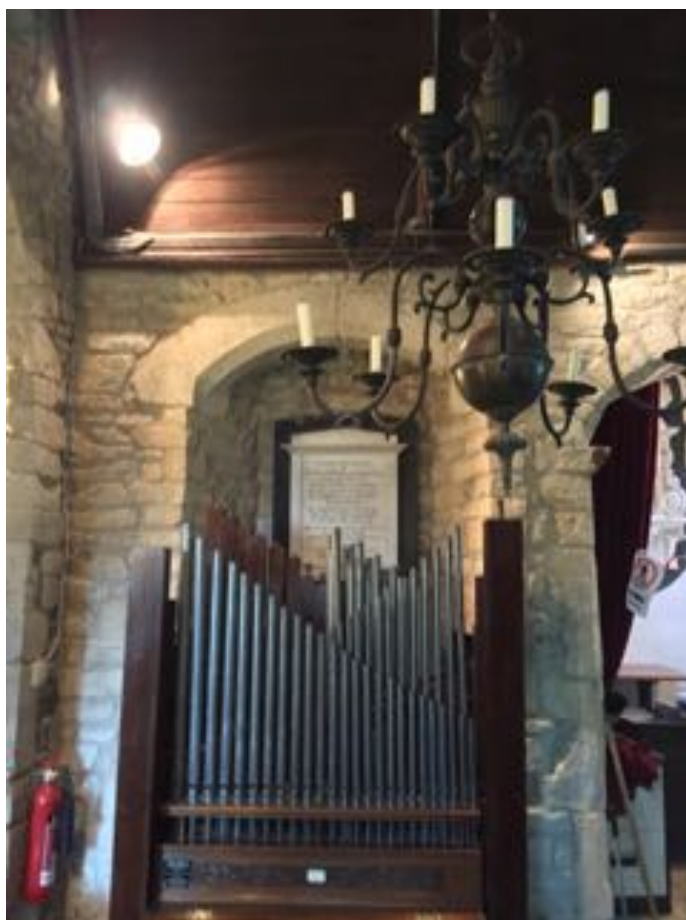
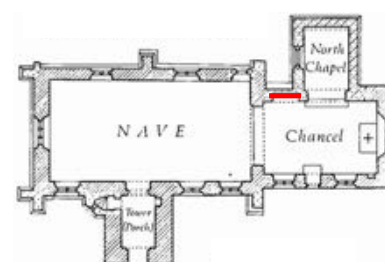
Ferrous fixings ~ condition unknown.

- Record all
- Closer inspection required
- No conservation required at this stage

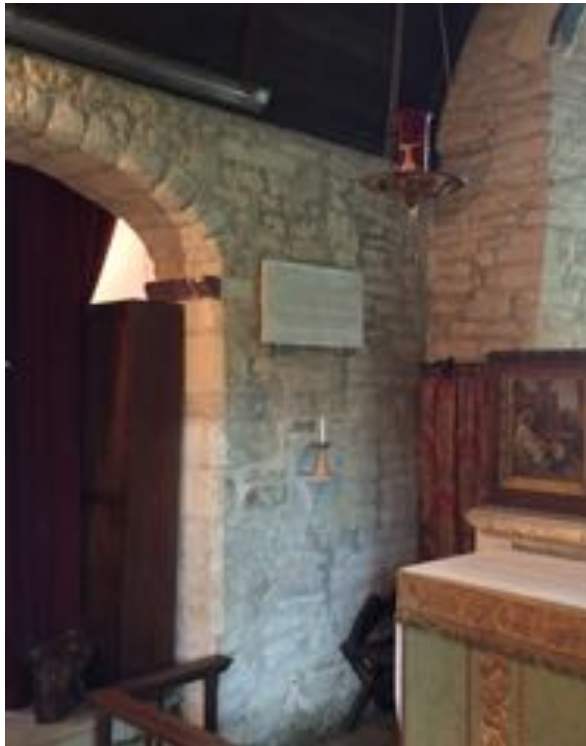
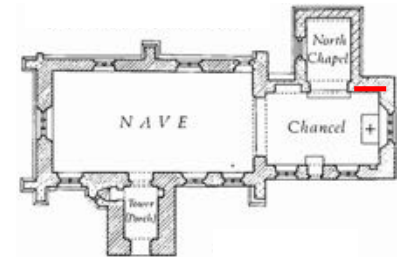
General ~ generally sound at present, however evidence of corroding fixings

Ferrous fixings ~ corroded. But no particular movement noted

Stability ~ secure, however the corrosion of the fixings is on going. Cement pointing to perimeter.

- Record all.
- Monitor fixings
- No conservation required at this stage but could be cleaned.

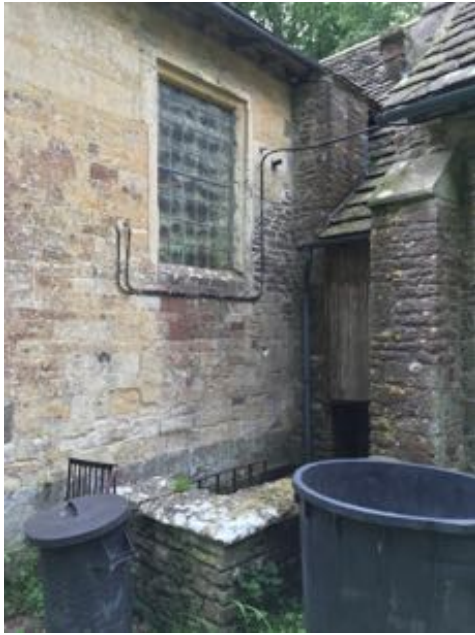
Figure 27 ~ West elevation of Newman Chapel with access to underground area. This area was inspected.
